BLUE BIRD

R10RK

**SUBJECT: RECALL R10RK BATTERY CABLE ROUTING AT REAR OF
LARGE BATTERY COMPARTMENT**

Battery Cable Routing at Battery Compartment

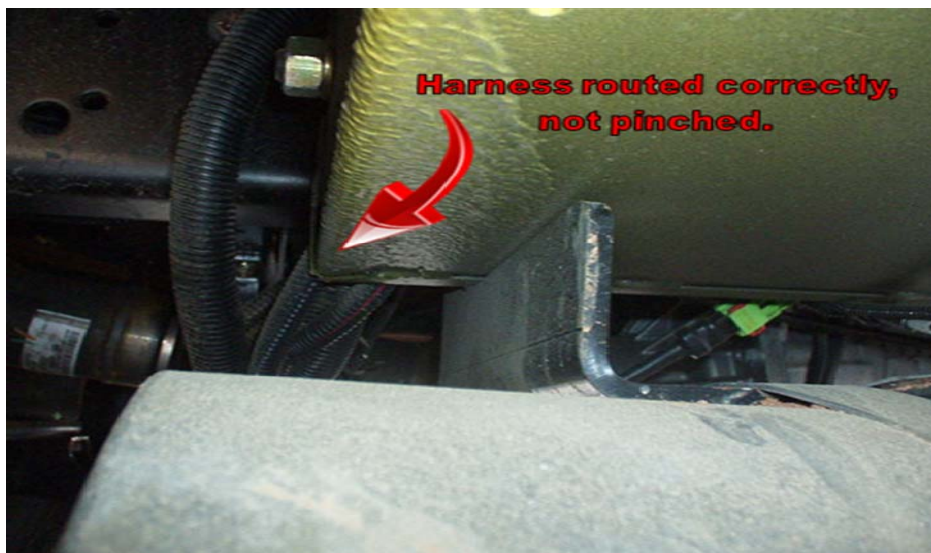
1. Park the bus on a level surface, apply parking brakes, turn off engine and remove ignition key.
2. Chock wheels.
3. If unit has air suspension, place jack stands under frame rails for inspection and/or correction to prevent frame from lowering should air bags deflate.
4. Disconnect Batteries - Note when disconnecting the batteries, remove the Negative cable first.
5. Inspect battery cables. If the battery cables are routed & secured behind battery compartment per photo below, no further action is required.

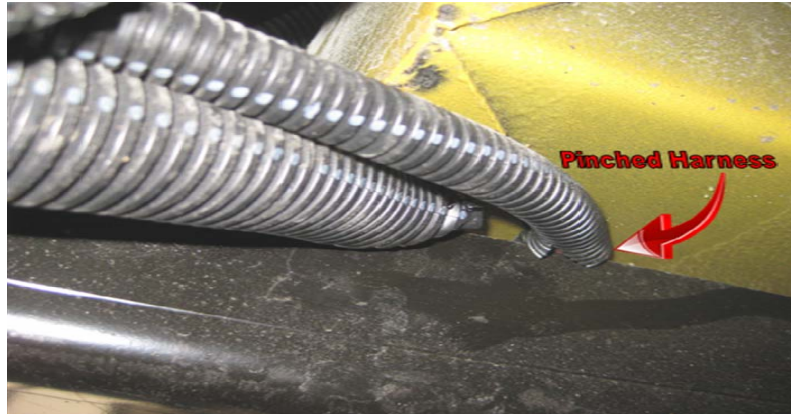
Positive battery cable may be pinched between bottom of battery compartment & muffler mounting bracket. Also, the front muffler exhaust bracket could be mounted in an incorrect location making it too close to bottom of battery compartment.

- 6. If any battery cables are pinched between the muffler mounting bracket and the front bottom side of the heavy duty battery compartment (See photos below) remove the clamps and zip strips securing cable, remove cable from between battery box and the muffler mounting bracket, remove loom and inspect cable for damage to insulation.

- 7. If cable is damaged, disconnect other end reference attached diagram D0003543), remove from chassis and replace w/new cable assembly.
- 8. If cable is pinched but not visibly damaged, then reroute cable to rear of heavy duty battery compartment and re-clamp/secure to hold in place per photo on page 1. Reference diagram D0003543 for cable routing.

Note: Cables must be routed/clamped to prevent contact with exhaust muffler. A minimum of 3 inches must be maintained between cables and exhaust muffler.
