**SUBJECT: SERVICE BULLETIN S10RX CHARGE AIR COOLER TUBE
SUPPORT BRACKET**

MODELS AFFECTED: 2010-2011 ALL AMERICAN (D3RE)

Models Affected: 2010-2011 All American (D3RE) with Cummins ISC Engines

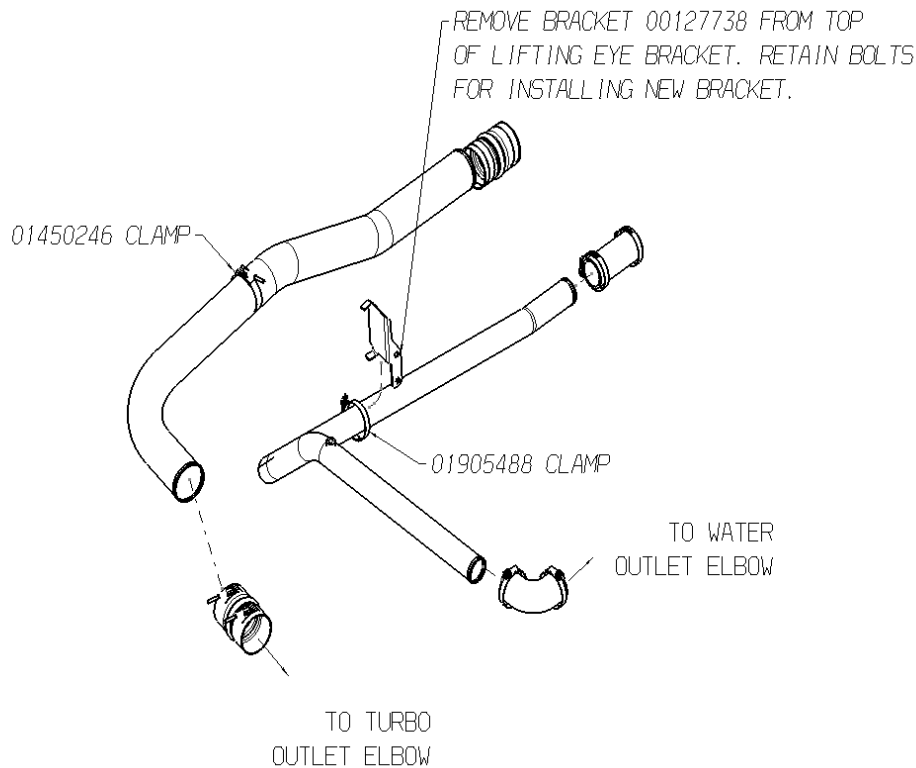
Charge air cooler tube support bracket may fail.

1. Park the bus on a level surface, apply parking brakes, turn off engine and remove keys. Chock wheels.
2. Remove existing charged air cooling tube support bracket, part number 00127738, and the related clamps per diagram below and discard. Retain fasteners to engine for use with new bracket.
