Fuel Tank Overfill Venting *UPDATE*

Model Affected: 2008-2011 Vision (BBCV), All American (A3FE, A3RE)
2010-2011 All American (D3FE, D3RE)

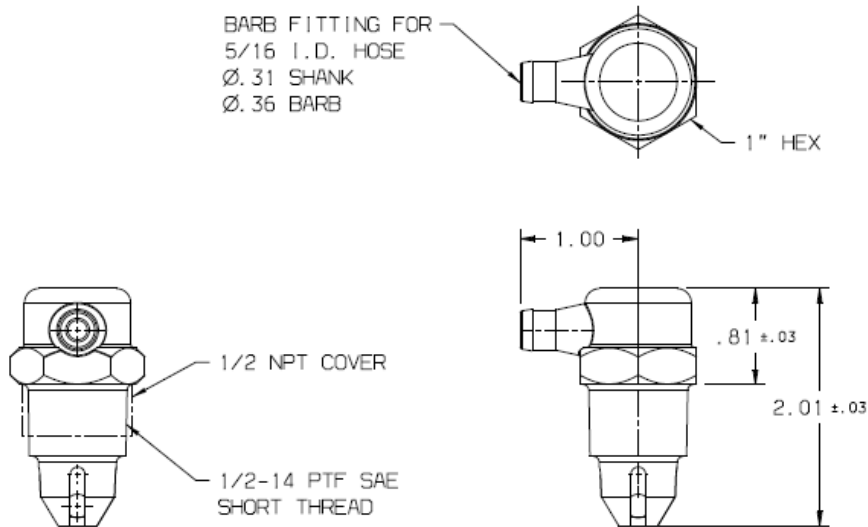
An overfilled tank may allow diesel fuel to seep out of the vent during warm weather conditions. To prevent this condition, make sure that the warning label on the fuel door that states “Do Not Fill More Than 95% of Liquid Capacity” is being followed and if needed, install the current production fuel tank vent (10013053). Also, check that the vent hose is clear of any obstructions and routed so as not to be pinched/kinked.

1. Park the bus on a level surface, apply parking brakes, turn off engine and remove keys. Chock wheels.
2. Follow standard replacement instructions to replace fuel tank vent with 10013053.
