**SUBJECT: SERVICE BULLETIN S10RY INTERMOTIVE GUARDIAN II
LIFT INTERLOCK WIRING**

MODELS AFFECTED: 2007-2011 MODEL YEAR MICRO BIRD

INTERMOTIVE GUARDIAN II LIFT INTERLOCK POWER SOURCE

Models Affected: 2007 - 2010 MICROBIRD Equipped With Feature 31048-07 Guardian II Lift Interlock

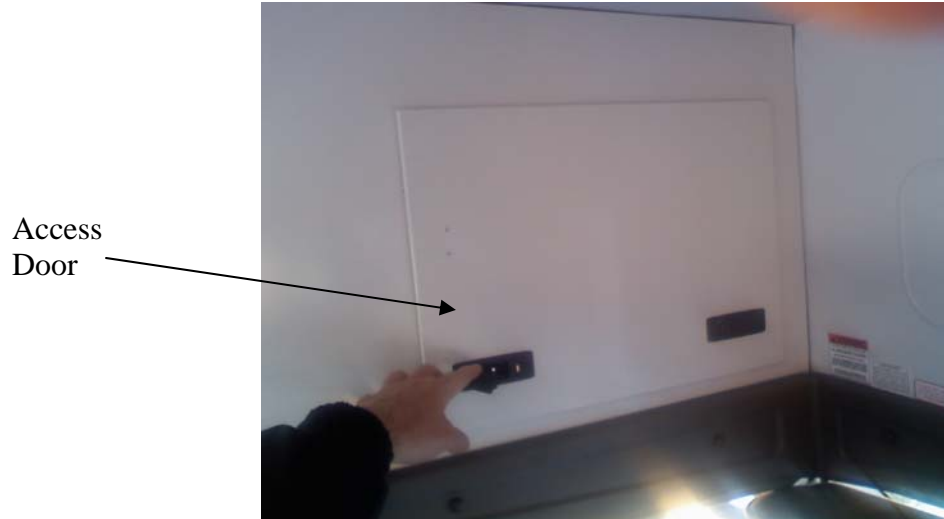
2. Unlatch and open access door above the driver seat. (See above photo)

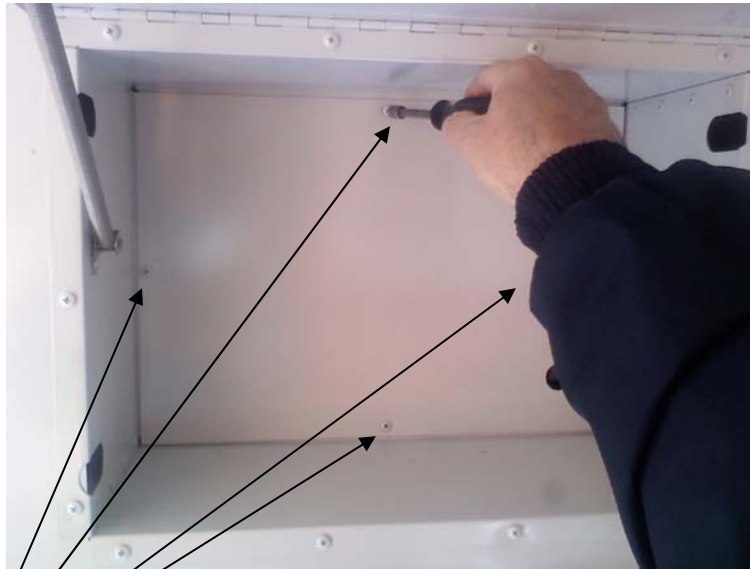
Remove Screws

3. Remove four screws that attach cover at rear of driver compartment. (See above photo)

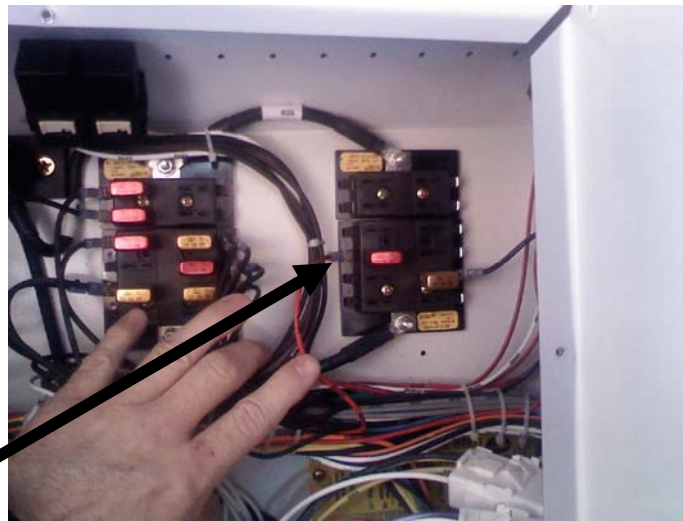
Some buses equipped with the Intermotive Guardian II lift interlock system were incorrectly built with circuit 2502B (Red Wire) connected to ignition power.

Example: 2502B And 10 Amp Breaker Connected to Ignition Powered Position.

4. Inspect circuit 2502B and determine if it is supplied by ignition or battery power. With ignition key OFF verify voltage on circuit 2502B with a meter or test light.
5. If circuit 2502B is supplied by battery power, no further action required. Replace cover and place bus back in service.

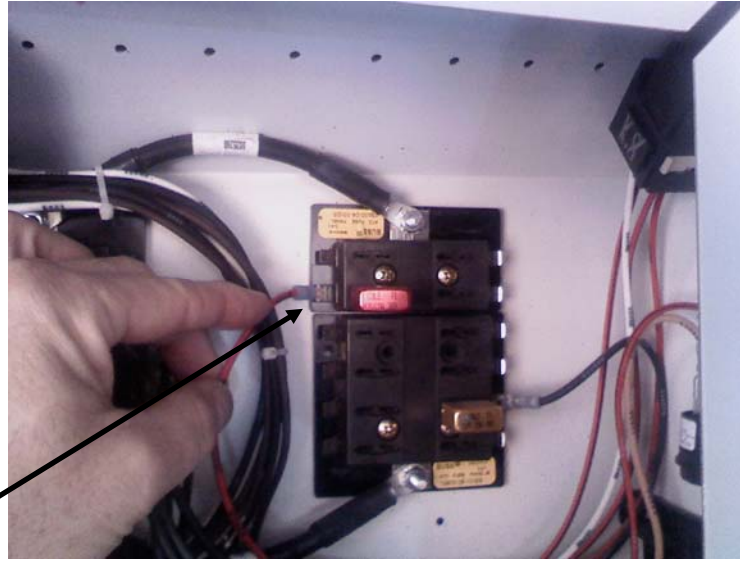
Example: 2502B And 10 Amp Breaker Relocated to Battery Powered Position.

6. If circuit 2502B is supplied by ignition power, relocate circuit 2502B and ten amp circuit breaker to any available fuse panel position that has battery power.
