BLUE BIRD

SERVICE MEMORANDUM
NO. SM0902

SUBJECT: WHEELCHAIR LIFT POWER CABLE ROUTING

MODELS AFFECTED: VISIONS EQUIPPED WITH CUMMINS ENGINE AND WHEELCHAIR LIFT

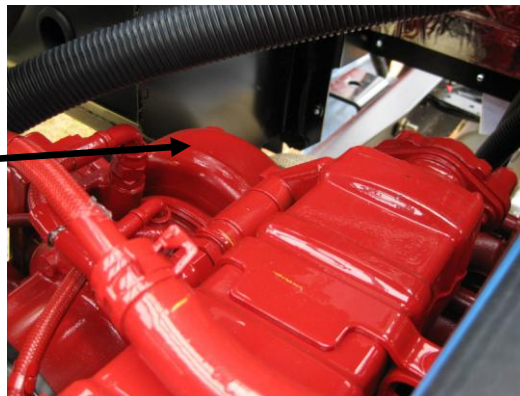
Turbocharger

The wheelchair lift power cable may be routed too close to the engine exhaust manifold and/or turbocharger on 2010 model year “Vision” buses equipped with a Cummins engine and wheelchair lift delivered from May 29, 2009 through September 09, 2009. **These buses must be inspected immediately to ensure a minimum 6” clearance between the wheelchair lift power cable and engine exhaust manifold and turbocharger.**
